# Access Compliance Report Public Rights-of-Way (Curb Ramps)

Main Street: RANCHWOOD\_RD Cross Street: IRVINE\_BLV Location: SE

ADA ID: RPRK211006113248 Ramp Type: Type 1 - Perpendicular Diagonal Initial Pass/Fail: Fail Overall Compliance: No Severity Score: 15

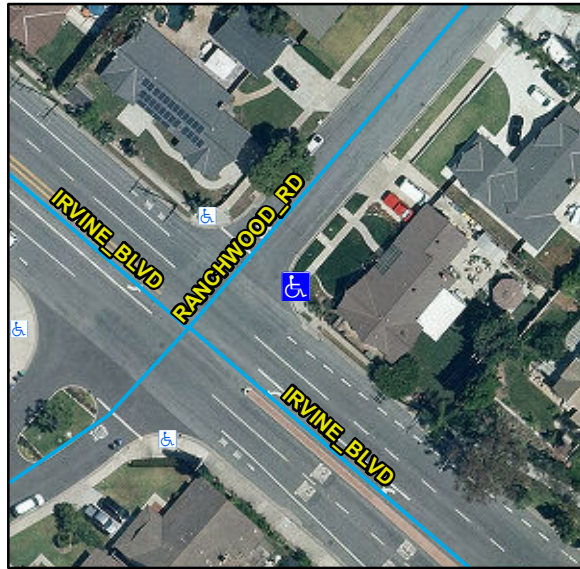
| Compliance | Description | Data | Compliance | Description | Data |
|---|---|---|---|---|---|
| No | Ramp Run Slope (%) | 9.8 | N/A | Flare Slope LT (%) | N/A |

**Remove & Replace Curb Ramp With Two New Directional Ramps or Equivalent.**
