# Access Compliance Report Public Rights-of-Way (Curb Ramps)

Main Street: RANCHWOOD\_RD Cross Street: TRAILS\_END\_LN Location: NW

ADA ID: RPRK211006113702 Ramp Type: Type 1 - Perpendicular Diagonal Initial Pass/Fail: Fail Overall Compliance: No Severity Score: 45

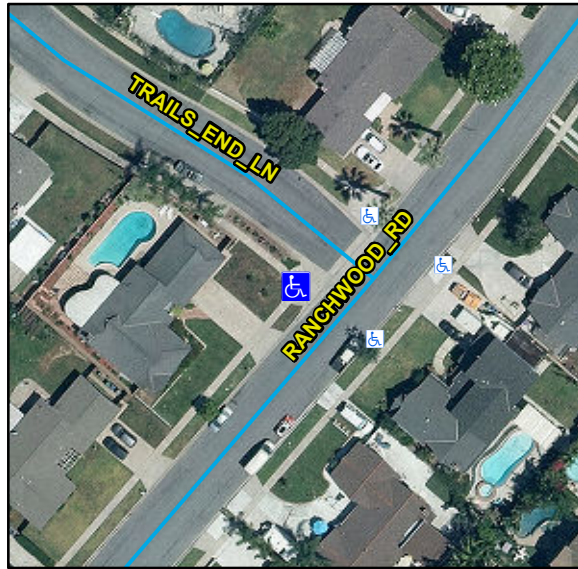
| Compliance | Description | Data | Compliance | Description | Data |
|---|---|---|---|---|---|
| No | Ramp Run Slope (%) | 12.5 | N/A | Flare Slope LT (%) | N/A |
| No | Ramp Cross Slope (%) | 5.9 | N/A | Flare Traversable LT | N/A |
| No | Gutter Lip Height (in) | 0.25 | | Road Run Slope (%) | 1.3 |

Remove & Replace Curb Ramp With Two New Directional Ramps or Equivalent.

R304.2.2, R204.3, R304.5.3, R302.7.2, STD 1115
