# Access Compliance Report Public Rights-of-Way (Curb Ramps)

Main Street: TRAILS\_END\_LN Cross Street: RANCHWOOD\_RD Location: NE

ADA ID: RPRK211006113908 Ramp Type: Type 1 - Perpendicular Diagonal Initial Pass/Fail: Fail Overall Compliance: No Severity Score: 16

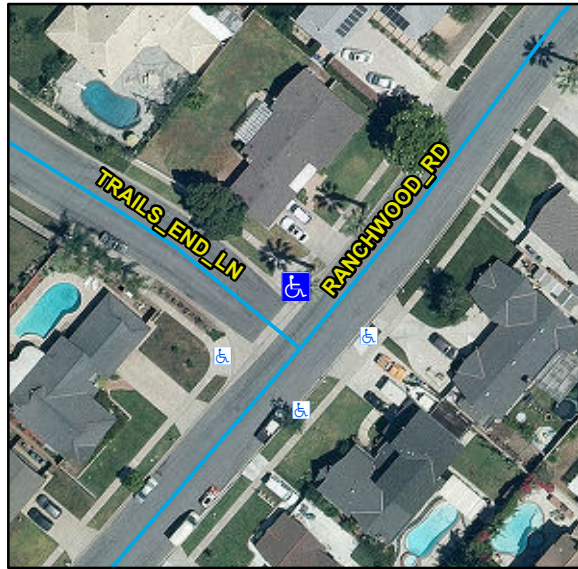
| Compliance | Description | Data | Compliance | Description | Data |
|---|---|---|---|---|---|
| No | Ramp Run Slope (%) | 11.1 | N/A | Flare Slope LT (%) | N/A |
| No | Ramp Cross Slope (%) | 2.7 | N/A | Flare Traversable LT | N/A |

Remove & Replace Curb Ramp With Two New Directional Ramps or Equivalent.

R304.2.2, R304.5.3, STD 1115
