# Access Compliance Report Public Rights-of-Way (Curb Ramps)

Main Street: EVENINGSIDE\_DR Cross Street: TRAILS\_END\_LN Location: SE

ADA ID: RPRK211006114234 Ramp Type: Type 1 - Perpendicular Diagonal Initial Pass/Fail: Fail Overall Compliance: No Severity Score: 16

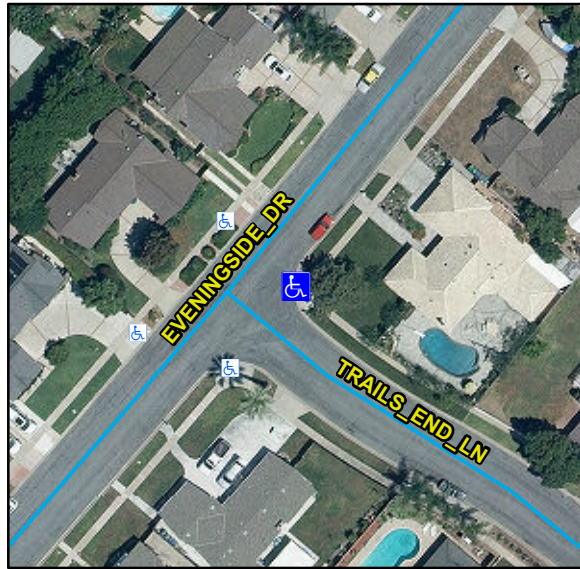
| Compliance | Description | Data | Compliance | Description | Data |
|---|---|---|---|---|---|
| No | Ramp Run Slope (%) | 10.9 | N/A | Flare Slope LT (%) | N/A |
| No | Ramp Cross Slope (%) | 2.3 | N/A | Flare Traversable LT | N/A |

Remove & Replace Curb Ramp With Two New Directional Ramps or Equivalent.
