# Access Compliance Report Public Rights-of-Way (Curb Ramps)

Main Street: TRAILS\_END\_LN Cross Street: EVENINGSIDE\_DR Location: SW

ADA ID: RPRK211006114401 Ramp Type: Type 1 - Perpendicular Diagonal Initial Pass/Fail: Fail Overall Compliance: No Severity Score: 15

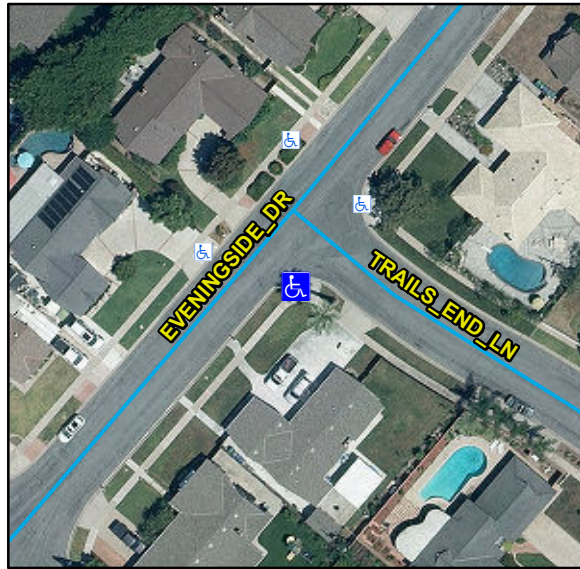
R304.2.2, R204.3, R304.5.3, STD 1115

| Compliance | Description | Data | Compliance | Description | Data |
|---|---|---|---|---|---|
| No | Ramp Cross Slope (%) | 6.3 | N/A | Flare Traversable LT | N/A |

Remove & Replace Curb Ramp With Two New Directional Ramps or Equivalent.
