# Access Compliance Report Public Rights-of-Way (Curb Ramps)

Main Street: RAINBOW\_DR Cross Street: RANCHWOOD\_RD Location: SW

ADA ID: RPRK211006115100 Ramp Type: Type 1 - Perpendicular Diagonal Initial Pass/Fail: Fail Overall Compliance: No Severity Score: 16

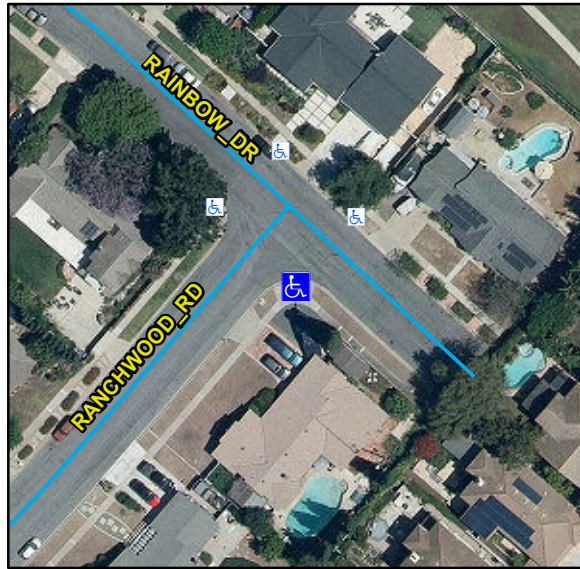
| Compliance | Description | Data | Compliance | Description | Data |
|---|---|---|---|---|---|
| No | Ramp Run Slope (%) | 10.9 | N/A | Flare Slope LT (%) | N/A |
| No | Ramp Cross Slope (%) | 2.6 | N/A | Flare Traversable LT | N/A |
| N/A | Gutter Ponding | N/A | No | Curb Slope | 13.7 |

**Remove & Replace Curb Ramp With Two New Directional Ramps or Equivalent.**

**R304.2.2, R204.3, R304.5.3, STD 1115**
