Access Compliance Report Public Rights-of-Way (Curb Ramps)

Main Street: RANCHWOOD_RD **Cross Street:** RAINBOW_DR **Location:** NW

ADA ID: RPRK211006115254 **Ramp Type:** Type 1 - Perpendicular Diagonal Initial Pass/Fail: Fail **Overall Compliance:** No **Severity Score:** 16

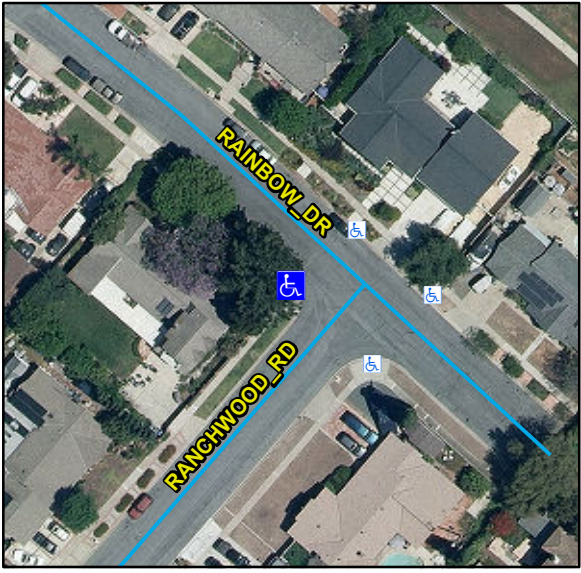
Compliance	Description	Data	Compliance	Description	Data
N/A	Ramp Length (in)	126	N/A	Flare Type LT	
Yes	Ramp Width (in)	48			N/A
No	Ramp Run Slope (%)	9.5	N/A	Flare Slope LT (%)	N/A
No	Ramp Cross Slope (%)	3.7	N/A	Flare Traversable LT	N/A
N/A	Landing Present	N/A	N/A	Flare Type RT	
N/A	Landing Length (in)	N/A			N/A
N/A	Landing Width (in)	N/A	N/A	Flare Slope RT (%)	N/A
N/A	Landing Run Slope (%)	N/A	N/A	Flare Traversable RT	N/A
N/A	Landing Cross Slope (%)	N/A	N/A	DWS Provided	N/A
N/A	Landing Movement Obstructed?	N/A	N/A	DWS Contrast	N/A
	Landing Movement Type	N/A	N/A	DWS Length (in)	N/A
N/A	Landing Shared	N/A	N/A	DWS Full Width	N/A
N/A	Clear Space	Yes	N/A	DWS Offset Left (in)	N/A
N/A	Clear Space To Crosswalk (in)	N/A	N/A	DWS Offset Right (in)	N/A
N/A	Marked Crosswalk 1	No	N/A	Marked Crosswalk 2	No
	Crossing 1 Direction	S		Crossing 2 Direction	E
	Marked Crosswalk 1 Width (in)	N/A		Marked Crosswalk 2 Width (in)	N/A

Possible Solutions:
Remove & Replace Curb Ramp With Two New Directional Ramps or Equivalent.

OC Std/PROW:
 R204.3, R304.2.2, R304.5.3, STD 1115

Total Cost: \$ 6160
