# Access Compliance Report Public Rights-of-Way (Curb Ramps)

Main Street: RAINBOW\_DR Cross Street: EVENINGSIDE\_DR Location: SW

ADA ID: RPRK211006115605 Ramp Type: Type 1 - Perpendicular Diagonal Initial Pass/Fail: Fail Overall Compliance: No Severity Score: 16

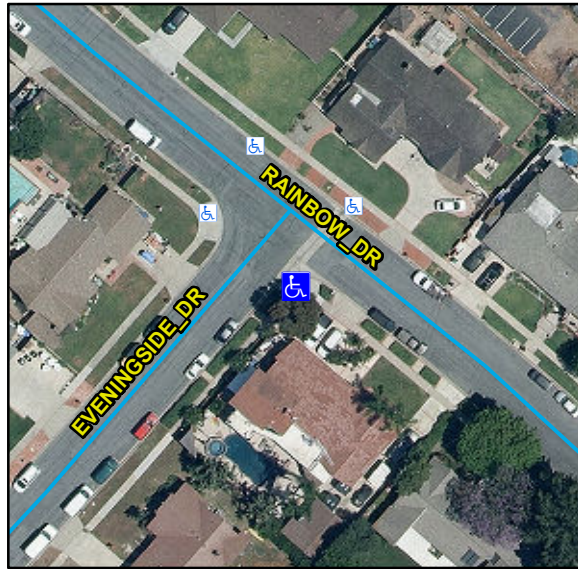
| Compliance | Description | Data | Compliance | Description | Data |
|---|---|---|---|---|---|
| No | Ramp Run Slope (%) | 10.4 | N/A | Flare Slope LT (%) | N/A |

**Remove & Replace Curb Ramp With Two New Directional Ramps or Equivalent.**
