# Access Compliance Report Public Rights-of-Way (Curb Ramps)

Main Street: EVENINGSIDE\_DR Cross Street: RAINBOW\_DR Location: NW

ADA ID: RPRK211006115808 Ramp Type: Type 1 - Perpendicular Diagonal Initial Pass/Fail: Fail Overall Compliance: No Severity Score: 16

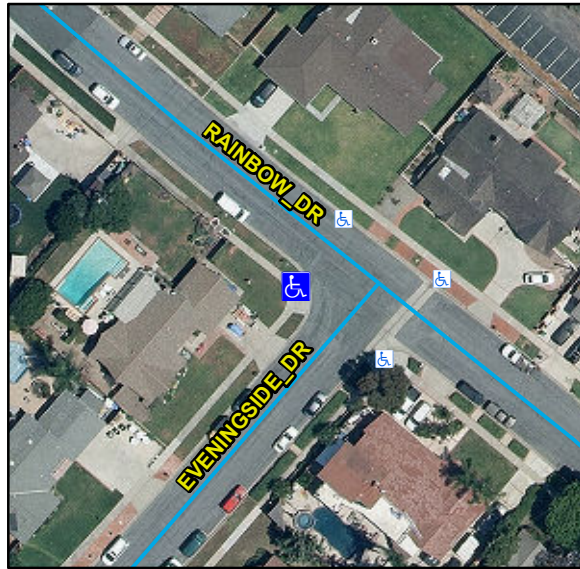
| Compliance | Description | Data | Compliance | Description | Data |
|---|---|---|---|---|---|
| No | Ramp Run Slope (%) | 9.6 | N/A | Flare Slope LT (%) | N/A |
| No | Ramp Cross Slope (%) | 3.5 | N/A | Flare Traversable LT | N/A |

**Remove & Replace Curb Ramp With Two New Directional Ramps or Equivalent.**

**R304.2.2, R204.3, R304.5.3, STD 1115**
