# Access Compliance Report Public Rights-of-Way (Curb Ramps)

Main Street: **BROWNING\_AVE** Cross Street: **RAINBOW\_DR** Location: **SE**

ADA ID: **RPRK211006120205** Ramp Type: **Type 1 - Perpendicular Diagonal** Initial Pass/Fail: **Fail** Overall Compliance: **No** Severity Score: **32**

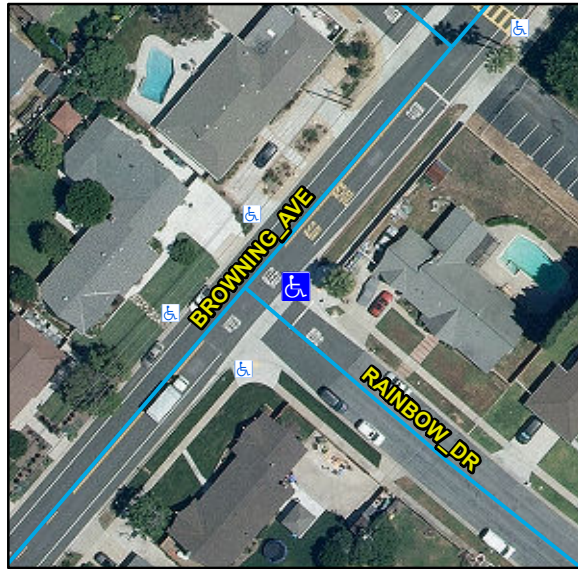
| Compliance | Description | Data | Compliance | Description | Data |
|---|---|---|---|---|---|
| <b>No</b> | Ramp Run Slope (%) | <b>13.6</b> | <b>N/A</b> | Flare Slope LT (%) | <b>N/A</b> |
| <b>No</b> | Ramp Cross Slope (%) | <b>2.8</b> | <b>N/A</b> | Flare Traversable LT | <b>N/A</b> |

**Remove & Replace Curb Ramp With Two New Directional Ramps or Equivalent.**

**R304.2.2, R304.5.3, STD 1115**
