# Access Compliance Report Public Rights-of-Way (Curb Ramps)

Main Street: RAINBOW\_DR Cross Street: BROWNING\_AVE Location: SW

ADA ID: RPRK211006120353 Ramp Type: Type 1 - Perpendicular Diagonal Initial Pass/Fail: Fail Overall Compliance: No Severity Score: 16

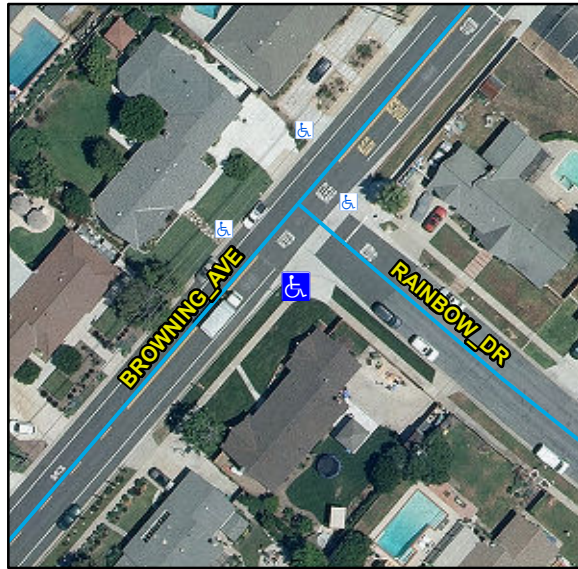
| Compliance | Description | Data | Compliance | Description | Data |
|---|---|---|---|---|---|
| No | Ramp Run Slope (%) | 11.6 | N/A | Flare Slope LT (%) | N/A |
| No | Ramp Cross Slope (%) | 3.2 | N/A | Flare Traversable LT | N/A |

Remove & Replace Curb Ramp With Two New Directional Ramps or Equivalent.

R304.2.2, R304.5.3, STD 1115
