Access Compliance Report Public Rights-of-Way (Curb Ramps)

Main Street: ETHELBEE_WAY **Cross Street:** SANTA_CLARA_AVE **Location:** NE

ADA ID: RPRK211006145720 **Ramp Type:** Type 1 - Perpendicular Diagonal Initial Pass/Fail: Fail **Overall Compliance:** No **Severity Score:** 15

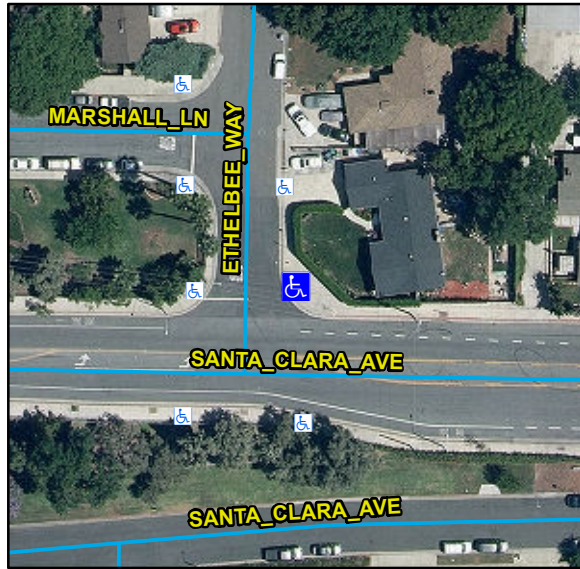
Compliance	Description	Data	Compliance	Description	Data
N/A	Ramp Length (in)	132	N/A	Flare Type LT	
Yes	Ramp Width (in)	48			N/A
No	Ramp Run Slope (%)	9.7	N/A	Flare Slope LT (%)	N/A
Yes	Ramp Cross Slope (%)	1.6	N/A	Flare Traversable LT	N/A
N/A	Landing Present	N/A	N/A	Flare Type RT	
N/A	Landing Length (in)	N/A			N/A
N/A	Landing Width (in)	N/A	N/A	Flare Slope RT (%)	N/A
N/A	Landing Run Slope (%)	N/A	N/A	Flare Traversable RT	N/A
N/A	Landing Cross Slope (%)	N/A	N/A	DWS Provided	N/A
N/A	Landing Movement Obstructed?	N/A	N/A	DWS Contrast	N/A
	Landing Movement Type	N/A	N/A	DWS Length (in)	N/A
N/A	Landing Shared	N/A	N/A	DWS Full Width	N/A
N/A	Clear Space	Yes	N/A	DWS Offset Left (in)	N/A
N/A	Clear Space To Crosswalk (in)	N/A	N/A	DWS Offset Right (in)	N/A
N/A	Marked Crosswalk 1	No	N/A	Marked Crosswalk 2	No
	Crossing 1 Direction	W		Crossing 2 Direction	S
	Marked Crosswalk 1 Width (in)	N/A		Marked Crosswalk 2 Width (in)	N/A

N/A	Ramp Inside Crosswalk 1	N/A	Yes	Ramp Inside Crosswalk 2	N/A
	Crossing 1 Slope (%)	14		Crossing 2 Slope (%)	5.1
	Crossing 1 Cross Slope (%)	1.9		Crossing 2 Cross Slope (%)	2.9
N/A	Gutter Ponding	N/A	No	Curb Slope	13.3
Yes	Gutter Lip Height (in)	0		Road Run Slope (%)	0.7
N/A	Gutter Run Slope (%)	N/A		Road Cross Slope (%)	2.9
N/A	Gutter Cross Slope (%)	N/A			
Yes	Overall Surface Condition: Acceptable		No	Perp Joint Present	No
	Cross Gutter Present?	No		Spandrel Present?	No
	Replace Cross Gutter?	N/A		Replace Spandrel?	N/A

Possible Solutions:
Remove & Replace Curb Ramp With Two New Directional Ramps or Equivalent.

OC Std/PROW:
 R304.2.2, R204.3, STD 1115
