# Access Compliance Report Public Rights-of-Way (Curb Ramps)

Main Street: SANTA\_CLARA\_AVE Cross Street: ETHELBEE\_WAY Location: NW

ADA ID: RPRK211006145923 Ramp Type: Type 1 - Perpendicular Diagonal Initial Pass/Fail: Fail Overall Compliance: No Severity Score: 32

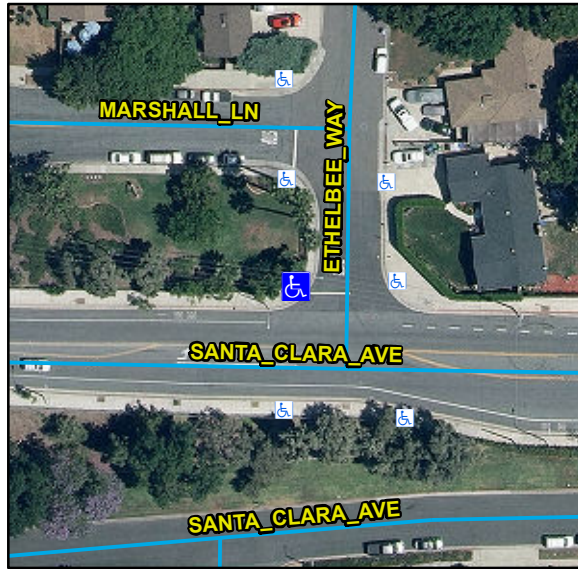
| Compliance | Description | Data | Compliance | Description | Data |
|---|---|---|---|---|---|
| No | Ramp Run Slope (%) | 13 | N/A | Flare Slope LT (%) | N/A |
| No | Ramp Cross Slope (%) | 2.6 | N/A | Flare Traversable LT | N/A |

Remove & Replace Curb Ramp With Two New Directional Ramps or Equivalent.

R304.2.2, R204.3, R304.5.3, STD 1115
