# Access Compliance Report Public Rights-of-Way (Curb Ramps)

Main Street: ETHELBEE\_WAY Cross Street: MARSHALL\_LN Location: SW

ADA ID: RPRK211006150222 Ramp Type: Type 1 - Perpendicular Diagonal Initial Pass/Fail: Fail Overall Compliance: No Severity Score: 16

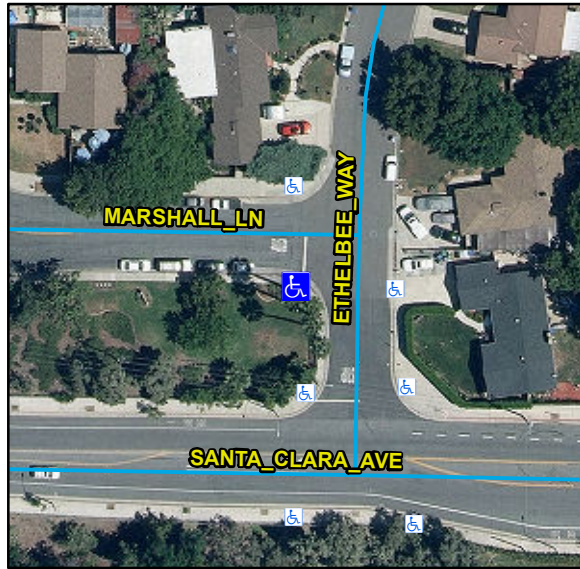
| Compliance | Description | Data | Compliance | Description | Data |
|---|---|---|---|---|---|
| No | Ramp Run Slope (%) | 11.6 | N/A | Flare Slope LT (%) | N/A |
| No | Ramp Cross Slope (%) | 3 | N/A | Flare Traversable LT | N/A |

Remove & Replace Curb Ramp With Two New Directional Ramps or Equivalent.
