# Access Compliance Report Public Rights-of-Way (Curb Ramps)

Main Street: MARSHALL\_LN Cross Street: ETHELBEE\_WAY Location: NW

ADA ID: RPRK211006150401 Ramp Type: Type 7 - Directional 2 Initial Pass/Fail: Fail Overall Compliance: No Severity Score: 45

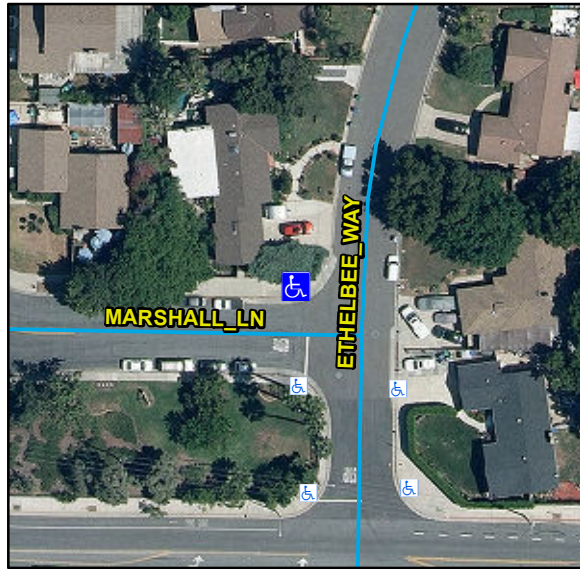
| Compliance | Description | Data | Compliance | Description | Data |
|---|---|---|---|---|---|
| No | Ramp Run Slope (%) | 15.6 | N/A | Flare Slope LT (%) | N/A |
| No | Ramp Cross Slope (%) | 5.8 | N/A | Flare Traversable LT | N/A |
| No | Gutter Lip Height (in) | 0.5 | | Road Run Slope (%) | N/A |

Remove & Replace Entire Ramp. Grind Gutter Lip.

R204.3, R304.2.2, R304.5.3, R302.7.2, STD 1115
