# Access Compliance Report Public Rights-of-Way (Curb Ramps)

| Main Street: YORBA_ST | | Cross Street: RAINIER_DR | | Location: | SW |
| ADA ID: RPRK211006151313 | Ramp Type: Type 7 - Directional 2 | Initial Pass/Fail: Fail | Overall Compliance: No | Severity Score: | 15 |

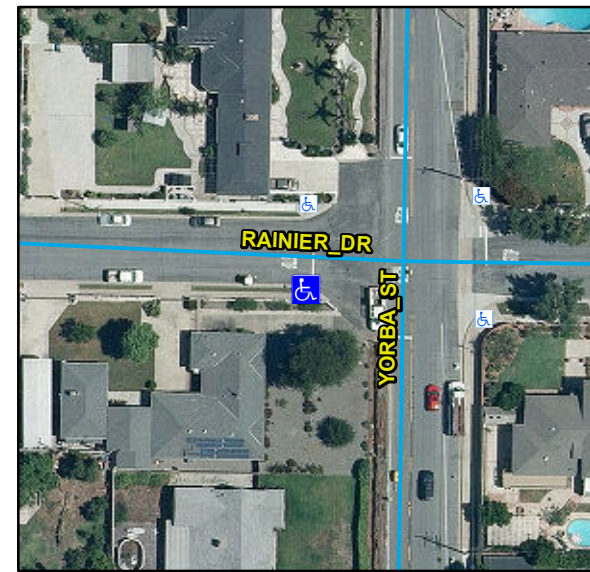
| Compliance | Description | Data | Compliance | Description | Data |
|---|---|---|---|---|---|
| No | Ramp Run Slope (%) | 10.3 | N/A | Flare Slope LT (%) | N/A |
| No | Gutter Lip Height (in) | 0.5 | | Road Run Slope (%) | N/A |

**Remove & Replace Entire Ramp. Grind Gutter Lip.**

**R204.3, R304.2.2, R302.7.2, STD 1115**

Total Cost: \$ 3230
