# Access Compliance Report Public Rights-of-Way (Curb Ramps)

Main Street: YORBA\_ST Cross Street: RAINIER\_DR Location: NW

ADA ID: RPRK211006151539 Ramp Type: Type 7 - Directional 2 Initial Pass/Fail: Fail Overall Compliance: No Severity Score: 15

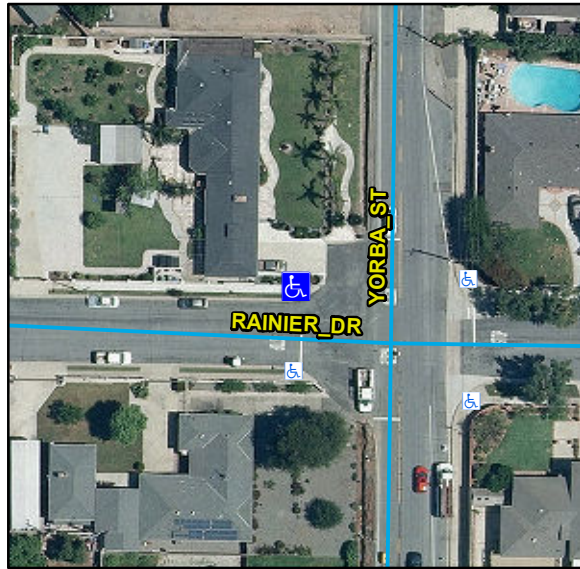
| Compliance | Description | Data | Compliance | Description | Data |
|---|---|---|---|---|---|
| <b>No</b> | Ramp Run Slope (%) | <b>10.8</b> | <b>N/A</b> | Flare Slope LT (%) | <b>N/A</b> |
| <b>No</b> | Gutter Lip Height (in) | <b>0.25</b> | | Road Run Slope (%) | <b>N/A</b> |

**Remove & Replace Entire Ramp. Grind Gutter Lip.**

**R204.3, R304.2.2, R302.7.2, STD 1115**
