# Access Compliance Report

## Public Rights-of-Way

### (Curb Ramps)

Main Street: YORBA\_ST Cross Street: RAINIER\_DR Location: NE

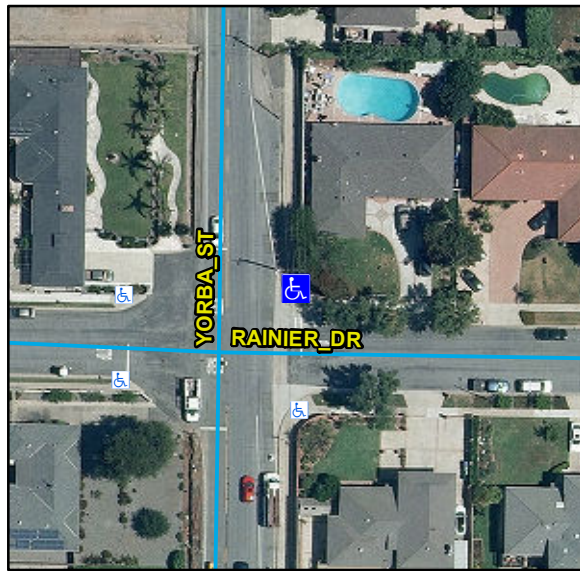
ADA ID: RPRK211006151724 Ramp Type: Type 1 - Perpendicular Diagonal Initial Pass/Fail: Fail Overall Compliance: No Severity Score: 32

| Compliance | Description | Data | Compliance | Description | Data |
|---|---|---|---|---|---|
| No | Ramp Run Slope (%) | 12.7 | N/A | Flare Slope LT (%) | N/A |
| No | Ramp Cross Slope (%) | 2.1 | N/A | Flare Traversable LT | N/A |
| No | Gutter Lip Height (in) | 0.25 | | Road Run Slope (%) | 0.7 |

**Remove & Replace Curb Ramp With Two New Directional Ramps or Equivalent.**

**R304.2.2, R304.5.3, R302.7.2, STD 1115**
