# Access Compliance Report Public Rights-of-Way (Curb Ramps)

Main Street: RAINIER\_DR Cross Street: YORBA\_ST Location: S

ADA ID: RPRK211006151942 Ramp Type: Type 1 - Perpendicular Diagonal Initial Pass/Fail: Fail Overall Compliance: No Severity Score: 15

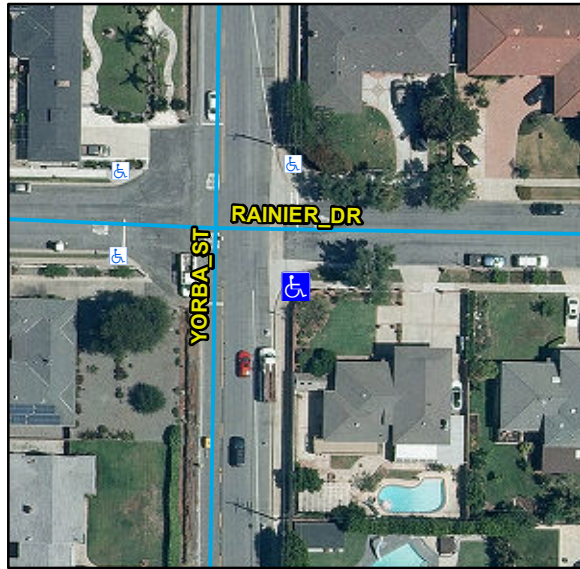
| Compliance | Description | Data | Compliance | Description | Data |
|---|---|---|---|---|---|
| No | Ramp Run Slope (%) | 12 | N/A | Flare Slope LT (%) | N/A |
| No | Gutter Lip Height (in) | 0.25 | | Road Run Slope (%) | 5 |

Remove & Replace Curb Ramp With Two New Directional Ramps or Equivalent.

R304.2.2, R302.7.2, STD 1115
