Access Compliance Report Public Rights-of-Way (Curb Ramps)

Main Street: RAINIER_DR **Cross Street:** ROSALIND_DR **Location:** NW

ADA ID: RPRK211006152304 **Ramp Type:** Type 1 - Perpendicular Diagonal Initial Pass/Fail: Fail **Overall Compliance:** No **Severity Score:** 15

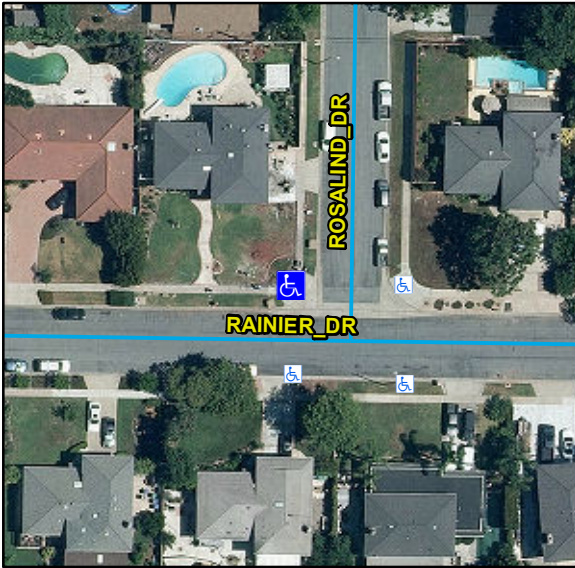
Compliance	Description	Data	Compliance	Description	Data
N/A	Ramp Length (in)	133	N/A	Flare Type LT	
Yes	Ramp Width (in)	48			N/A
No	Ramp Run Slope (%)	9.6	N/A	Flare Slope LT (%)	N/A
Yes	Ramp Cross Slope (%)	0.8	N/A	Flare Traversable LT	N/A
N/A	Landing Present	N/A	N/A	Flare Type RT	
N/A	Landing Length (in)	N/A			N/A
N/A	Landing Width (in)	N/A	N/A	Flare Slope RT (%)	N/A
N/A	Landing Run Slope (%)	N/A	N/A	Flare Traversable RT	N/A
N/A	Landing Cross Slope (%)	N/A	N/A	DWS Provided	N/A
N/A	Landing Movement Obstructed?	N/A	N/A	DWS Contrast	N/A
	Landing Movement Type	N/A	N/A	DWS Length (in)	N/A
N/A	Landing Shared	N/A	N/A	DWS Full Width	N/A
N/A	Clear Space	Yes	N/A	DWS Offset Left (in)	N/A
N/A	Clear Space To Crosswalk (in)	N/A	N/A	DWS Offset Right (in)	N/A
N/A	Marked Crosswalk 1	No	N/A	Marked Crosswalk 2	No
	Crossing 1 Direction	S		Crossing 2 Direction	E
	Marked Crosswalk 1 Width (in)	N/A		Marked Crosswalk 2 Width (in)	N/A

N/A	Ramp Inside Crosswalk 1	N/A	Yes	Ramp Inside Crosswalk 2	N/A
	Crossing 1 Slope (%)	7.5		Crossing 2 Slope (%)	1.2
	Crossing 1 Cross Slope (%)	2.6		Crossing 2 Cross Slope (%)	0.8
N/A	Gutter Ponding	N/A	No	Curb Slope	13.5
Yes	Gutter Lip Height (in)	0		Road Run Slope (%)	1.4
N/A	Gutter Run Slope (%)	N/A		Road Cross Slope (%)	6.2
N/A	Gutter Cross Slope (%)	N/A			
Yes	Overall Surface Condition:	Acceptable	No	Perp Joint Present	No
	Cross Gutter Present?	Yes		Spandrel Present?	Yes
	Replace Cross Gutter?	No		Replace Spandrel?	No

Possible Solutions:
Remove & Replace Curb Ramp With Two New Directional Ramps or Equivalent.

OC Std/PROW:
 R304.2.2, R204.3, STD 1115
