# Access Compliance Report Public Rights-of-Way (Curb Ramps)

Main Street: ROSALIND\_DR Cross Street: RAINIER\_DR Location: NE

ADA ID: RPRK211006152451 Ramp Type: Type 1 - Perpendicular Diagonal Initial Pass/Fail: Fail Overall Compliance: No Severity Score: 15

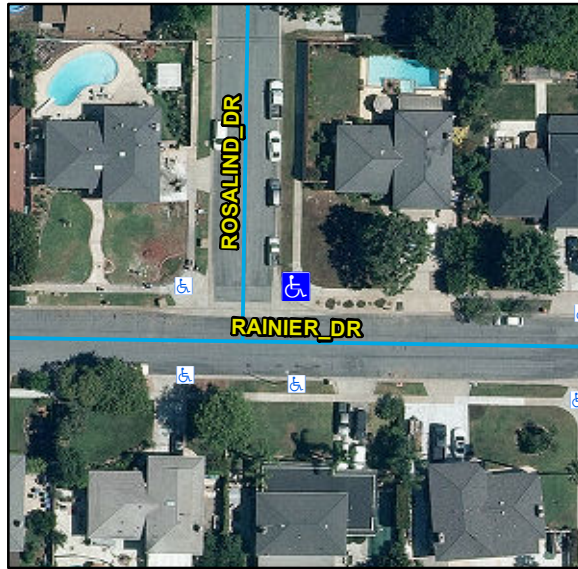
| Compliance | Description | Data | Compliance | Description | Data |
|---|---|---|---|---|---|
| No | Ramp Run Slope (%) | 11.8 | N/A | Flare Slope LT (%) | N/A |

Remove & Replace Curb Ramp With Two New Directional Ramps or Equivalent.

R304.2.2, R204.3, STD 1115
