# Access Compliance Report Public Rights-of-Way (Curb Ramps)

Main Street: LORETTA\_DR Cross Street: E\_SANTA\_CLARA\_AVE Location: NE

ADA ID: RPRK211006153455 Ramp Type: Type 1 - Perpendicular Diagonal Initial Pass/Fail: Fail Overall Compliance: No Severity Score: 16

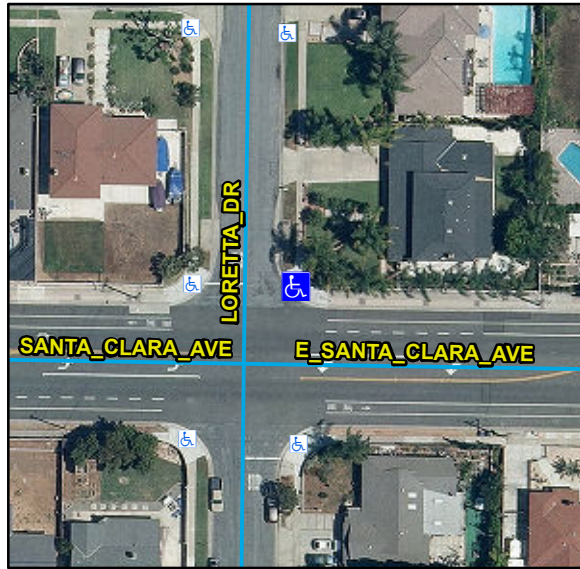
| Compliance | Description | Data | Compliance | Description | Data |
|---|---|---|---|---|---|
| No | Ramp Run Slope (%) | 10.2 | N/A | Flare Slope LT (%) | N/A |
| No | Ramp Cross Slope (%) | 2.3 | N/A | Flare Traversable LT | N/A |

Remove & Replace Curb Ramp With Two New Directional Ramps or Equivalent.

R304.2.2, R304.5.3, STD 1115
