# Access Compliance Report

## Public Rights-of-Way

### (Curb Ramps)

Main Street: E\_SANTA\_CLARA\_AVE Cross Street: LORETTA\_DR Location: SE

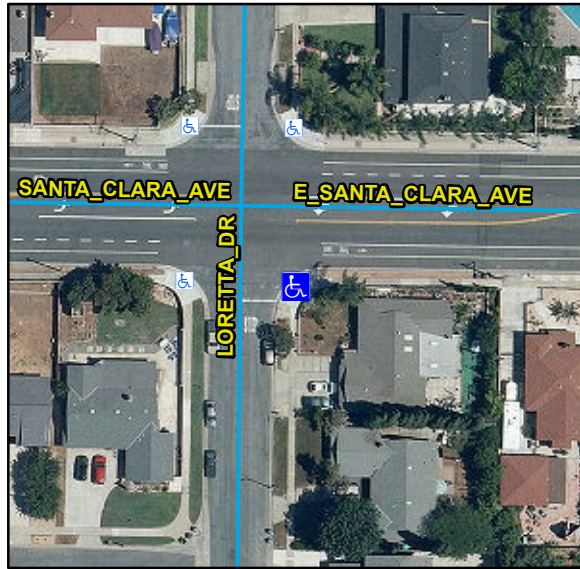
ADA ID: RPRK211006153648 Ramp Type: Type 1 - Perpendicular Diagonal Initial Pass/Fail: Fail Overall Compliance: No Severity Score: 15

| Compliance | Description | Data | Compliance | Description | Data |
|---|---|---|---|---|---|
| No | Ramp Run Slope (%) | 9.8 | N/A | Flare Slope LT (%) | N/A |
| N/A | Gutter Ponding | N/A | No | Curb Slope | 9.3 |

**Remove & Replace Curb Ramp With Two New Directional Ramps or Equivalent.**

**R304.2.2, STD 1115**

Total Cost: \$ 6160
