# Access Compliance Report Public Rights-of-Way (Curb Ramps)

Main Street: LORETTA\_DR Cross Street: SANTA\_CLARA\_AVE Location: SW

ADA ID: RPRK211006153904 Ramp Type: Type 1 - Perpendicular Diagonal Initial Pass/Fail: Fail Overall Compliance: No Severity Score: 16

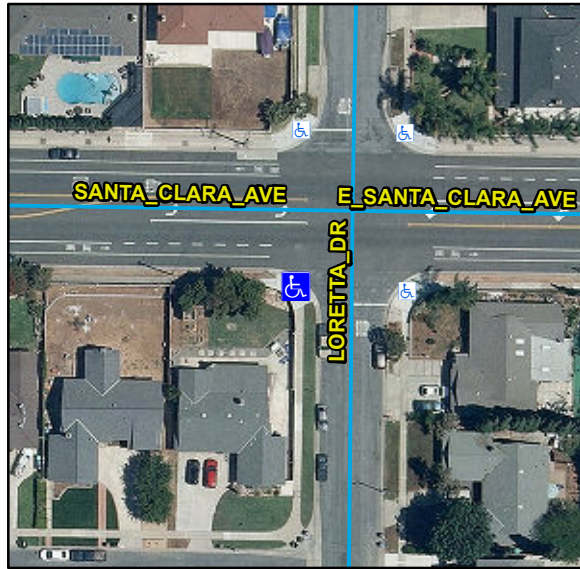
| Compliance | Description | Data | Compliance | Description | Data |
|---|---|---|---|---|---|
| No | Ramp Run Slope (%) | 10.3 | N/A | Flare Slope LT (%) | N/A |
| No | Ramp Cross Slope (%) | 3.6 | N/A | Flare Traversable LT | N/A |

Remove & Replace Curb Ramp With Two New Directional Ramps or Equivalent.

R304.2.2, R304.5.3, STD 1115
