# Access Compliance Report Public Rights-of-Way (Curb Ramps)

| Main Street: HEWES_ST | | Cross Street: FOWLER_AVE | | Location: | NE |
| ADA ID: RPRK211006165112 | Ramp Type:Type 1 - Perpendicular Diagonal Initial Pass/Fail: Fail | | Overall Compliance: No | Severity Score: | 30 |

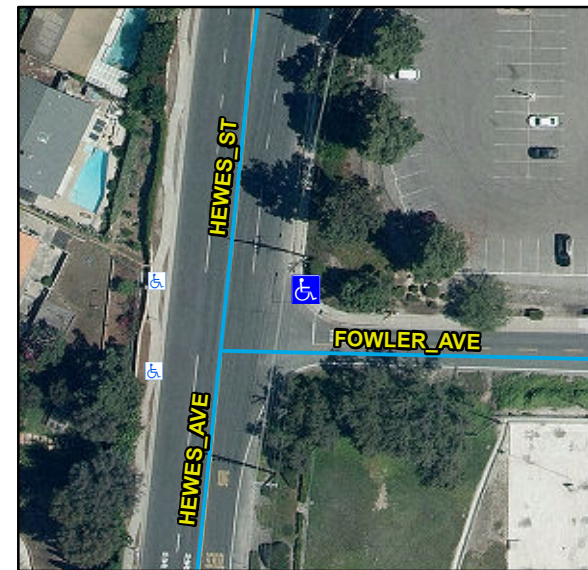
| Compliance | Description | Data | Compliance | Description | Data |
|---|---|---|---|---|---|
| No | Ramp Run Slope (%) | 8.8 | N/A | Flare Slope LT (%) | N/A |
| No | Ramp Cross Slope (%) | 5.1 | N/A | Flare Traversable LT | N/A |

**Remove & Replace Curb Ramp With Two New Directional Ramps or Equivalent.**

**R304.2.2, R304.5.3, STD 1115**

Total Cost: \$ 6160
