# Access Compliance Report Public Rights-of-Way (Curb Ramps)

Main Street: CHARMAINE\_LN Cross Street: FOWLER\_AVE Location: SW

ADA ID: RPRK211006170546 Ramp Type: Type 7 - Directional 2 Initial Pass/Fail: Fail Overall Compliance: No Severity Score: 16

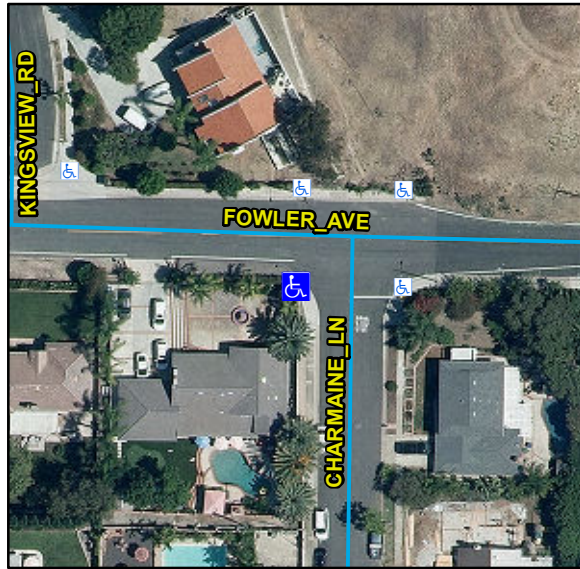
| Compliance | Description | Data | Compliance | Description | Data |
|---|---|---|---|---|---|
| No | Ramp Run Slope (%) | 9.7 | N/A | Flare Slope LT (%) | N/A |
| No | Ramp Cross Slope (%) | 2.6 | N/A | Flare Traversable LT | N/A |

Remove & Replace Entire Ramp.

R204.3, R304.2.2, R304.5.3, STD 1115

Total Cost: \$ 3080
