# Access Compliance Report Public Rights-of-Way (Curb Ramps)

| Main Street: PARKVIEW_TE | | Cross Street: CHARMAINE_LN | | Location: | NW |
| ADA ID: RPRK211006171252 | Ramp Type:Type 1 - Perpendicular Diagonal Initial Pass/Fail: Fail | | Overall Compliance: No | Severity Score: | 45 |

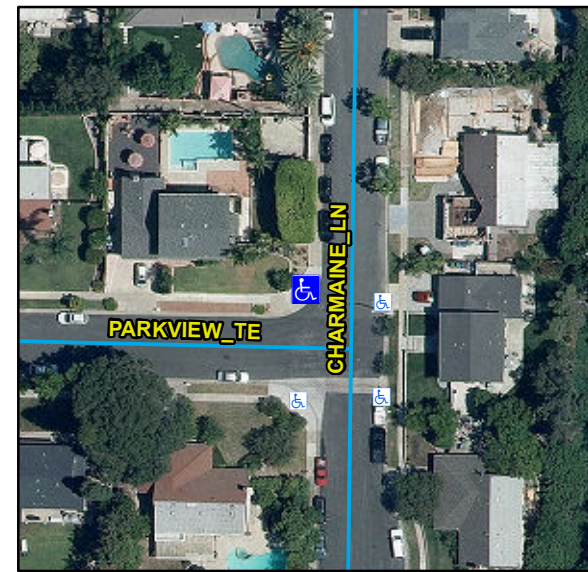
| Compliance | Description | Data | Compliance | Description | Data |
|---|---|---|---|---|---|
| No | Ramp Run Slope (%) | 10.3 | N/A | Flare Slope LT (%) | N/A |
| No | Ramp Cross Slope (%) | 9.4 | N/A | Flare Traversable LT | N/A |

**Remove & Replace Curb Ramp With Two New Directional Ramps or Equivalent.**

**R304.2.2, R204.3, R304.5.3, STD 1115**

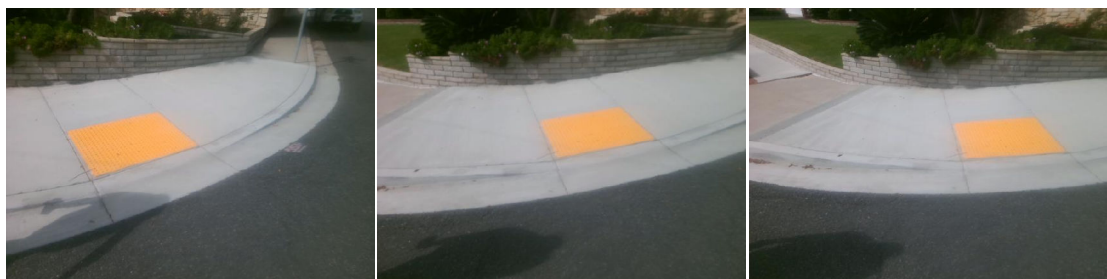
| Compliance | Description | Data | Compliance | Description | Data |
|---|---|---|---|---|---|
| N/A | Ramp Length (in) | 100 | N/A | Flare Type LT | |
| Yes | Ramp Width (in) | 48 | | | N/A |
| | Crossing 1 Slope (%) | 9.7 | | Crossing 2 Slope (%) | 12.5 |
| | Crossing 1 Cross Slope (%) | 8.7 | | Crossing 2 Cross Slope (%) | 8.3 |
