# Access Compliance Report Public Rights-of-Way (Curb Ramps)

Main Street: FAIRHAVEN\_AVE Cross Street: S\_WINTHROPE\_ST Location: NW

ADA ID: RPRK211006174917 Ramp Type: Type 1 - Perpendicular Diagonal Initial Pass/Fail: Fail Overall Compliance: No Severity Score: 2

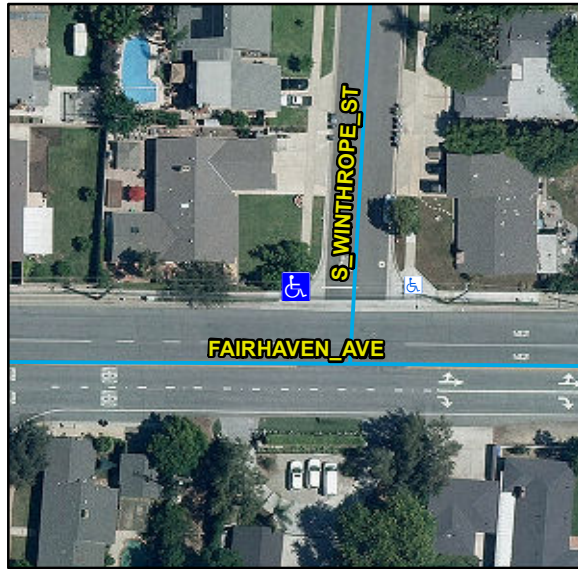
| Compliance | Description | Data | Compliance | Description | Data |
|---|---|---|---|---|---|
| No | Ramp Cross Slope (%) | 4.5 | N/A | Flare Traversable LT | N/A |

Remove & Replace Curb Ramp With Two New Directional Ramps or Equivalent.

R304.2.2, R304.5.3, STD 1115
