# Access Compliance Report Public Rights-of-Way (Curb Ramps)

Main Street: S\_NEWHAVEN\_DR Cross Street: FAIRHAVEN\_AVE Location: NE

ADA ID: RPRK211006175253 Ramp Type: Type 1 - Perpendicular Diagonal Initial Pass/Fail: Fail Overall Compliance: No Severity Score: 16

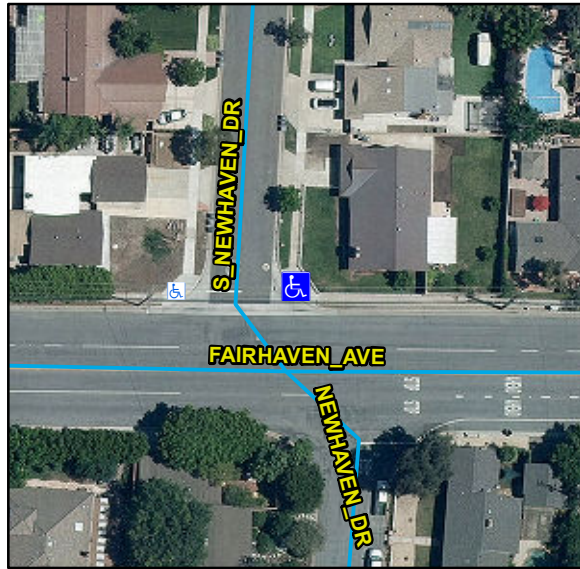
| Compliance | Description | Data | Compliance | Description | Data |
|---|---|---|---|---|---|
| No | Ramp Run Slope (%) | 8.4 | N/A | Flare Slope LT (%) | N/A |

Remove & Replace Curb Ramp With Two New Directional Ramps or Equivalent.

R304.2.2, STD 1115
