# Access Compliance Report Public Rights-of-Way (Curb Ramps)

Main Street: FAIRHAVEN\_AVE Cross Street: S\_NEWHAVEN\_DR Location: NW

ADA ID: RPRK211006175431 Ramp Type: Type 1 - Perpendicular Diagonal Initial Pass/Fail: Fail Overall Compliance: No Severity Score: 16

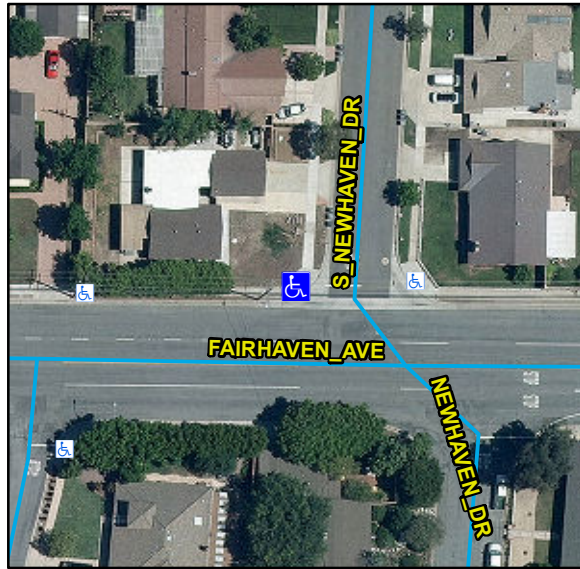
| Compliance | Description | Data | Compliance | Description | Data |
|---|---|---|---|---|---|
| No | Ramp Run Slope (%) | 11.7 | N/A | Flare Slope LT (%) | N/A |
| No | Ramp Cross Slope (%) | 2.7 | N/A | Flare Traversable LT | N/A |

Remove & Replace Curb Ramp With Two New Directional Ramps or Equivalent.

R304.2.2, R304.5.3, STD 1115
