# Access Compliance Report Public Rights-of-Way (Curb Ramps)

Main Street: E\_FAIRHAVEN\_AVE Cross Street: EARLHAM\_ST Location: NW

ADA ID: RPRK211006175940 Ramp Type: Type 1 - Perpendicular Diagonal Initial Pass/Fail: Fail Overall Compliance: No Severity Score: 16

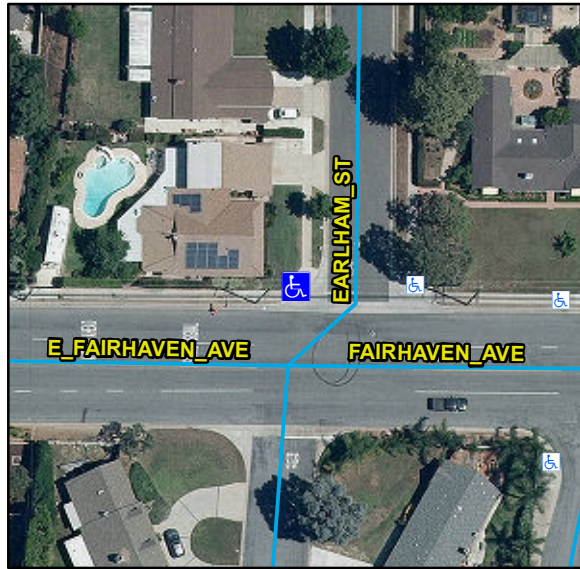
| Compliance | Description | Data | Compliance | Description | Data |
|---|---|---|---|---|---|
| No | Ramp Run Slope (%) | 10.2 | N/A | Flare Slope LT (%) | N/A |
| No | Ramp Cross Slope (%) | 3.8 | N/A | Flare Traversable LT | N/A |

Remove & Replace Curb Ramp With Two New Directional Ramps or Equivalent.

R304.2.2, R304.5.3, STD 1115
