# Access Compliance Report Public Rights-of-Way (Curb Ramps)

Main Street: FAIRHAVEN\_AVE Cross Street: HEWES\_AVE Location: NW

ADA ID: RPRK211006181241 Ramp Type: Type 1 - Perpendicular Diagonal Initial Pass/Fail: Pass Overall Compliance: No Severity Score: 10

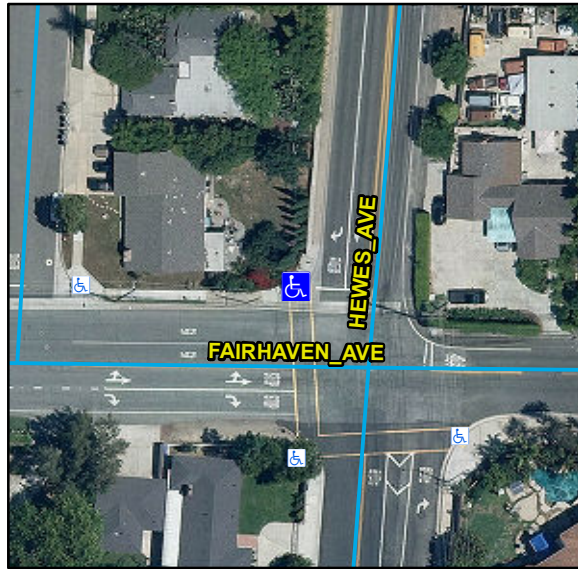
| Compliance | Description | Data | Compliance | Description | Data |
|---|---|---|---|---|---|
| No | Landing Width (in) | N/A | Yes | Flare Slope RT (%) | 4.3 |
| No | Landing Run Slope (%) | N/A | N/A | Flare Traversable RT | Yes |
| No | Landing Cross Slope (%) | N/A | Yes | DWS Provided | Yes |
| Yes | Gutter Ponding | No | No | Curb Slope | 15.2 |
| No | Gutter Cross Slope (%) | 2.1 | | | |

Remove & Replace Curb Ramp With Two New Directional Ramps or Equivalent. Remove & Replace Gutter.
