# Access Compliance Report Public Rights-of-Way (Curb Ramps)

Main Street: HEWES\_AVE Cross Street: FAIRHAVEN\_AVE Location: SW

ADA ID: RPRK211006181538 Ramp Type: Type 7 - Directional 2 Initial Pass/Fail: Fail Overall Compliance: No Severity Score: 2

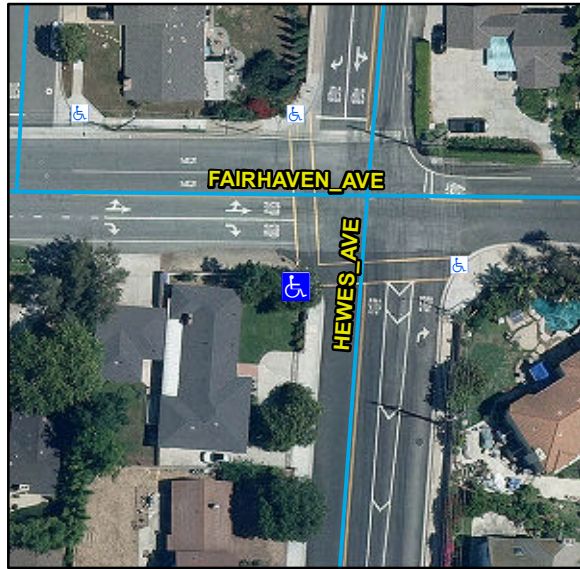
| Compliance | Description | Data | Compliance | Description | Data |
|---|---|---|---|---|---|
| No | Ramp Cross Slope (%) | 4.8 | N/A | Flare Traversable LT | N/A |

**Remove & Replace Curb Ramp With Two New Directional Ramps or Equivalent.**

**R304.5.3, STD 1115**
