# Access Compliance Report Public Rights-of-Way (Curb Ramps)

Main Street: FAIRHAVEN\_AVE Cross Street: HEWES\_AVE Location: SE

ADA ID: RPRK211006181852 Ramp Type: Type 1 - Perpendicular Diagonal Initial Pass/Fail: Fail Overall Compliance: No Severity Score: 16

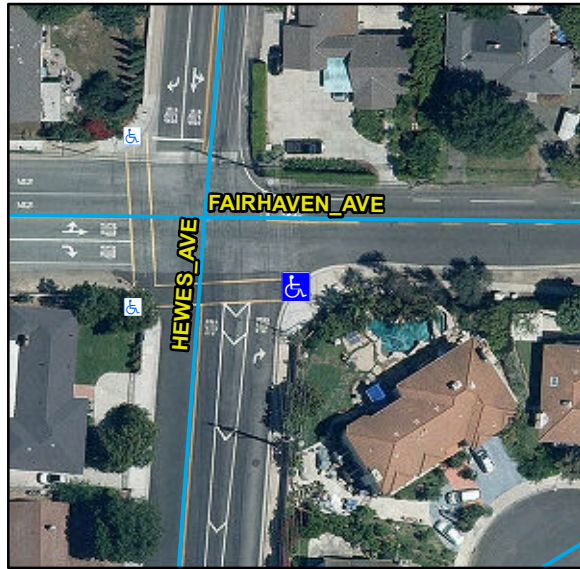
| Compliance | Description | Data | Compliance | Description | Data |
|---|---|---|---|---|---|
| No | Ramp Run Slope (%) | 11.5 | N/A | Flare Slope LT (%) | N/A |
| No | Ramp Cross Slope (%) | 2.5 | N/A | Flare Traversable LT | N/A |

Remove & Replace Curb Ramp With Two New Directional Ramps or Equivalent.

R304.2.2, R304.5.3, STD 1115
