# Access Compliance Report Public Rights-of-Way (Curb Ramps)

Main Street: ETON\_PL Cross Street: FAIRHAVEN\_AVE Location: SW

ADA ID: RPRK211007110847 Ramp Type: Type 1 - Perpendicular Diagonal Initial Pass/Fail: Fail Overall Compliance: No Severity Score: 16

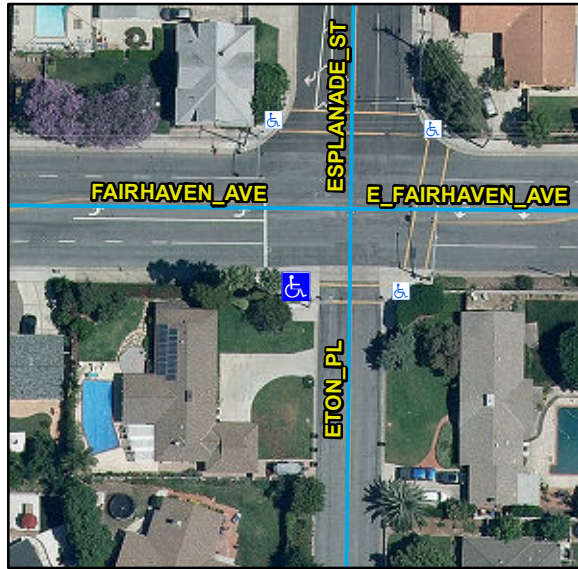
| Compliance | Description | Data | Compliance | Description | Data |
|---|---|---|---|---|---|
| No | Ramp Run Slope (%) | 10.4 | N/A | Flare Slope LT (%) | N/A |
| No | Ramp Cross Slope (%) | 2.9 | N/A | Flare Traversable LT | N/A |

Remove & Replace Curb Ramp With Two New Directional Ramps or Equivalent. Restripe Crosswalk.

R304.2.2, R304.5.3, STD 1115
