# Access Compliance Report Public Rights-of-Way (Curb Ramps)

Main Street: FAIRHAVEN\_AVE Cross Street: ESPLANADE\_AVE Location: SE

ADA ID: RPRK211007111532 Ramp Type: Type 1 - Perpendicular Diagonal Initial Pass/Fail: Fail Overall Compliance: No Severity Score: 15

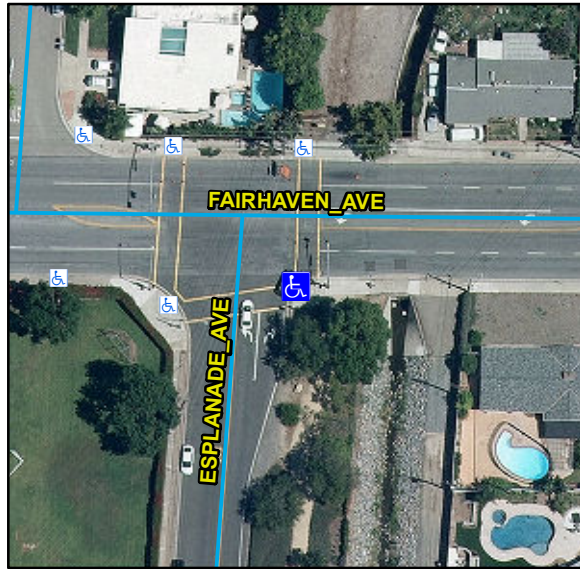
| Compliance | Description | Data | Compliance | Description | Data |
|---|---|---|---|---|---|
| No | Ramp Run Slope (%) | 11.5 | N/A | Flare Slope LT (%) | N/A |
| N/A | Ramp Inside Crosswalk 1 | Yes | Yes | Ramp Inside Crosswalk 2 | Yes |

Remove & Replace Curb Ramp With Two New Directional Ramps or Equivalent.

R304.2.2, R204.3, STD 1115
