# Access Compliance Report Public Rights-of-Way (Curb Ramps)

Main Street: FAIRHAVEN\_AVE Cross Street: ESPLANADE\_AVE Location: NW

ADA ID: RPRK211007112617 Ramp Type: Type 1 - Perpendicular Initial Pass/Fail: Fail Overall Compliance: No Severity Score: 2

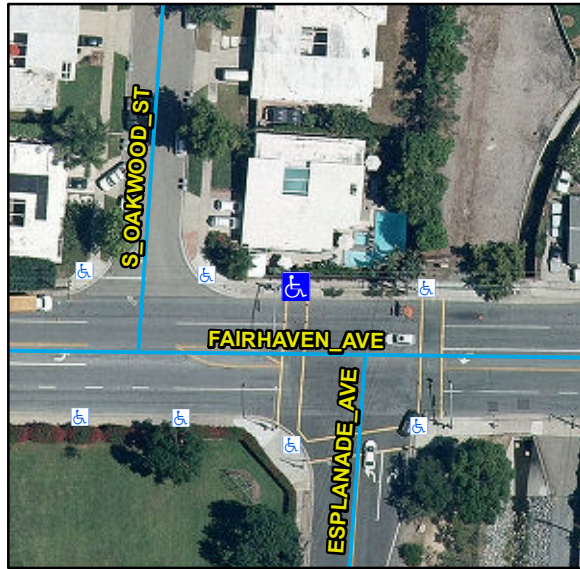
| Compliance | Description | Data | Compliance | Description | Data |
|---|---|---|---|---|---|
| No | Ramp Cross Slope (%) | 3.1 | N/A | Flare Traversable LT | N/A |
| N/A | Gutter Ponding | N/A | No | Curb Slope | 14.8 |

Remove & Replace Entire Ramp.

R304.2.2, R304.5.3, STD 1115
