# Access Compliance Report Public Rights-of-Way (Curb Ramps)

Main Street: S\_OAKWOOD\_ST Cross Street: FAIRHAVEN\_AVE Location: NE

ADA ID: RPRK211007112735 Ramp Type: Type 1 - Perpendicular Diagonal Initial Pass/Fail: Pass Overall Compliance: No Severity Score: 15

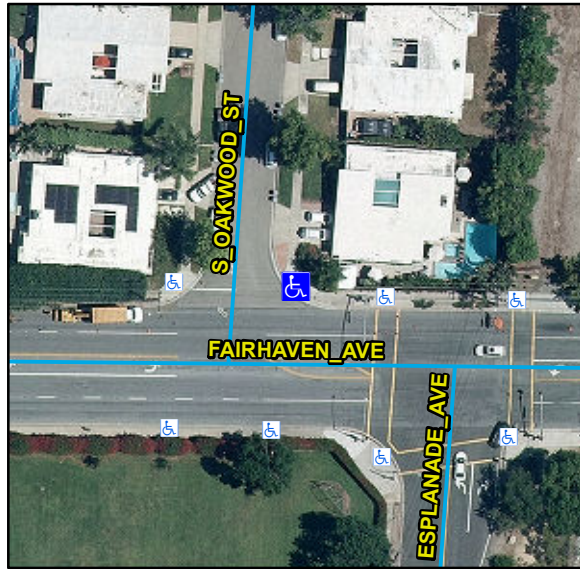
| Compliance | Description | Data | Compliance | Description | Data |
|---|---|---|---|---|---|
| No | Landing Width (in) | N/A | Yes | Flare Slope RT (%) | 5.5 |
| No | Landing Run Slope (%) | N/A | N/A | Flare Traversable RT | Yes |
| No | Landing Cross Slope (%) | N/A | Yes | DWS Provided | Yes |
| Yes | Gutter Ponding | No | No | Curb Slope | 10.1 |
| No | Gutter Run Slope (%) | 10 | | Road Cross Slope (%) | 9.3 |

Remove & Replace Curb Ramp With Two New Directional Ramps or Equivalent. Remove & Replace Gutter.
