# Access Compliance Report Public Rights-of-Way (Curb Ramps)

Main Street: S\_WOODLAND\_ST Cross Street: E\_FAIRHAVEN\_AVE Location: NE

ADA ID: RPRK211007113944 Ramp Type: Type 1 - Perpendicular Diagonal Initial Pass/Fail: Fail Overall Compliance: No Severity Score: 0

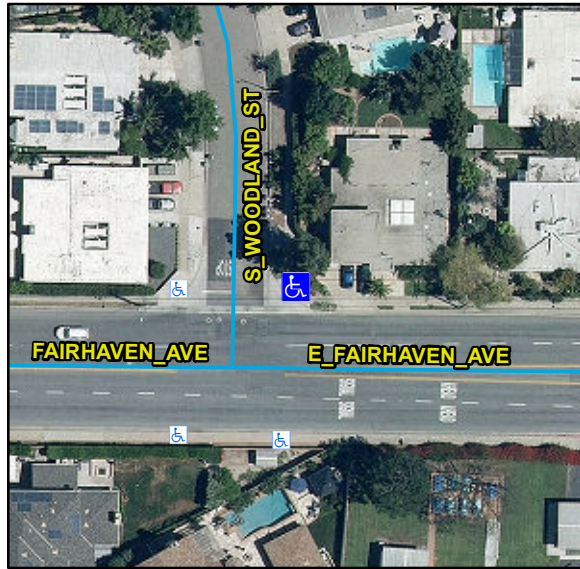
| Compliance | Description | Data | Compliance | Description | Data |
|---|---|---|---|---|---|
| N/A | Gutter Ponding | No | No | Curb Slope | 13.7 |

Remove & Replace Curb Ramp With Two New Directional Ramps or Equivalent.

R304.2.2, STD 1115
