# Access Compliance Report Public Rights-of-Way (Curb Ramps)

Main Street: FAIRHAVEN\_AVE Cross Street: S\_WOODLAND\_ST Location: NW

ADA ID: RPRK211007114309 Ramp Type: Type 1 - Perpendicular Diagonal Initial Pass/Fail: Fail Overall Compliance: No Severity Score: 2

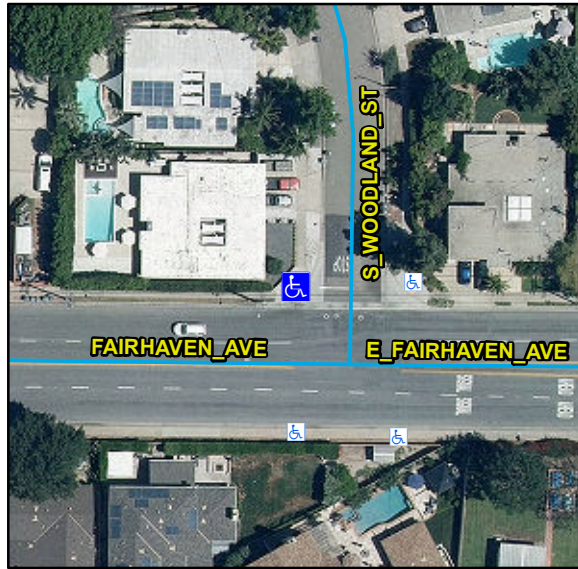
| Compliance | Description | Data | Compliance | Description | Data |
|---|---|---|---|---|---|
| No | Ramp Cross Slope (%) | 2.2 | N/A | Flare Traversable LT | N/A |

Remove & Replace Curb Ramp With Two New Directional Ramps or Equivalent.

R304.2.2, R304.5.3, STD 1115

Total Cost: \$ 6160
