# Access Compliance Report Public Rights-of-Way (Curb Ramps)

Main Street: ESPLANADE\_ST Cross Street: STEARNS\_AVE Location: SW

ADA ID: RPRK211007115330 Ramp Type: Type 1 - Perpendicular Diagonal Initial Pass/Fail: Fail Overall Compliance: No Severity Score: 15

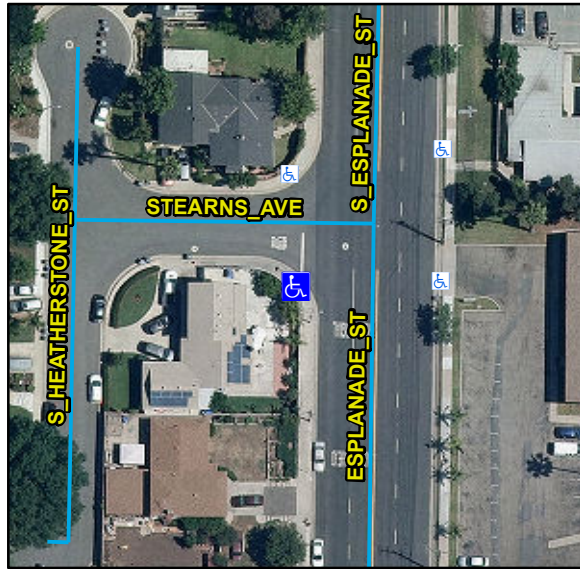
| Compliance | Description | Data | Compliance | Description | Data |
|---|---|---|---|---|---|
| No | Ramp Run Slope (%) | 9.8 | N/A | Flare Slope LT (%) | N/A |

Remove & Replace Curb Ramp With Two New Directional Ramps or Equivalent.

R304.2.2, STD 1115
