# Access Compliance Report Public Rights-of-Way (Curb Ramps)

| Main Street: 17TH_ST | | Cross Street: ESPLANADE_AVE | | Location: | NW |
| ADA ID: RPRK211007121642 | Ramp Type: Type 1 - Perpendicular Diagonal Initial Pass/Fail: Fail | | Overall Compliance: No | Severity Score: | 16 |

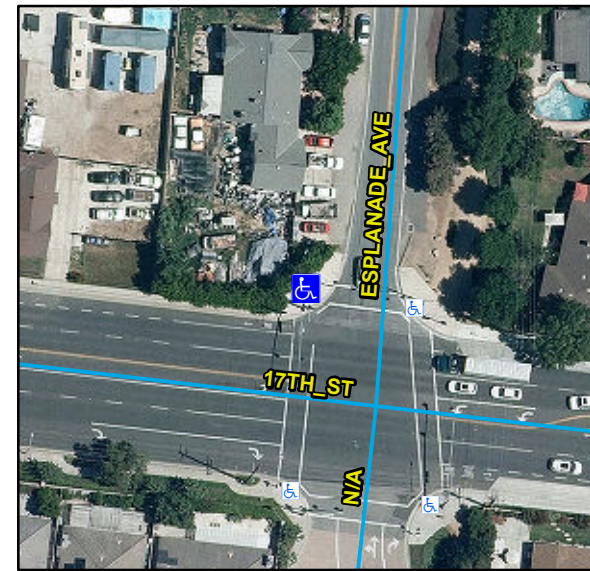
| Compliance | Description | Data | Compliance | Description | Data |
|---|---|---|---|---|---|
| No | Ramp Run Slope (%) | 11.3 | N/A | Flare Slope LT (%) | N/A |
| No | Ramp Cross Slope (%) | 3.4 | N/A | Flare Traversable LT | N/A |

**Remove & Replace Curb Ramp With Two New Directional Ramps or Equivalent.**
