# Access Compliance Report Public Rights-of-Way (Curb Ramps)

Main Street: **BRENAN\_WAY** Cross Street: **17TH\_ST** Location: **SW**

ADA ID: **RPRK211007123021** Ramp Type: **Type 7 - Directional 2** Initial Pass/Fail: **Fail** Overall Compliance: **No** Severity Score: **15**

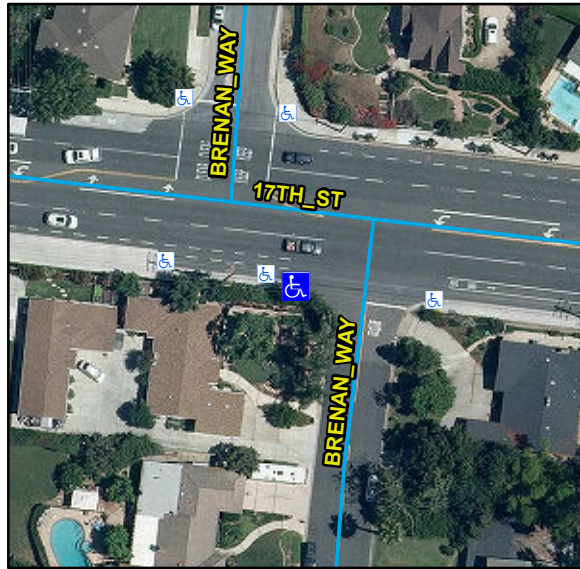
| Compliance | Description | Data | Compliance | Description | Data |
|---|---|---|---|---|---|
| <b>No</b> | Ramp Run Slope (%) | <b>11.4</b> | <b>N/A</b> | Flare Slope LT (%) | <b>N/A</b> |

**Remove & Replace Entire Ramp.**

**R204.3, R304.2.2, STD 1115**
