# Access Compliance Report Public Rights-of-Way (Curb Ramps)

Main Street: **BRENAN\_WAY** Cross Street: **17TH\_ST** Location: **S**

ADA ID: **RPRK211007123316** Ramp Type: **Type 7 - Directional 2** Initial Pass/Fail: **Fail** Overall Compliance: **No** Severity Score: **32**

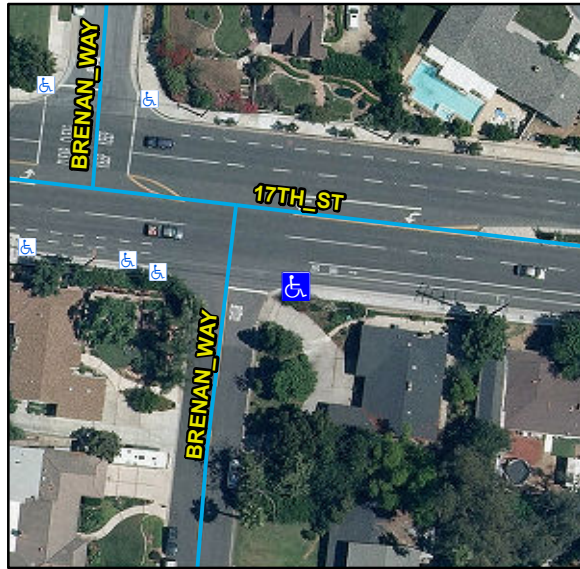
| Compliance | Description | Data | Compliance | Description | Data |
|---|---|---|---|---|---|
| <b>No</b> | Ramp Cross Slope (%) | <b>3.1</b> | <b>N/A</b> | Flare Traversable LT | <b>N/A</b> |

**Remove & Replace Entire Ramp.**

**R304.5.3, STD 1115**
