# Access Compliance Report Public Rights-of-Way (Curb Ramps)

| Main Street: STRATTON_WAY | | Cross Street: 17TH_ST | | Location: | SE |
| ADA ID: RPRK211007124227 | Ramp Type: Type 7 - Directional 2 | Initial Pass/Fail: Fail | Overall Compliance: No | Severity Score: | 32 |

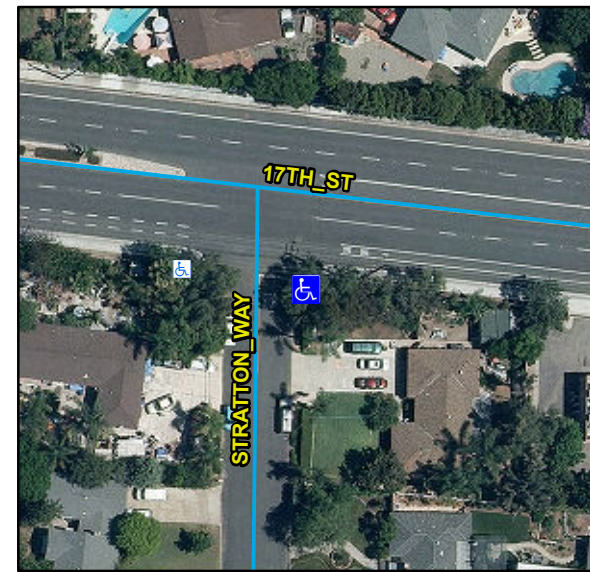
| Compliance | Description | Data | Compliance | Description | Data |
|---|---|---|---|---|---|
| No | Ramp Cross Slope (%) | 2.8 | N/A | Flare Traversable LT | N/A |

Possible Solutions:

Remove & Replace Entire Ramp.

R304.5.3, STD 1115

Total Cost: \$ 3080

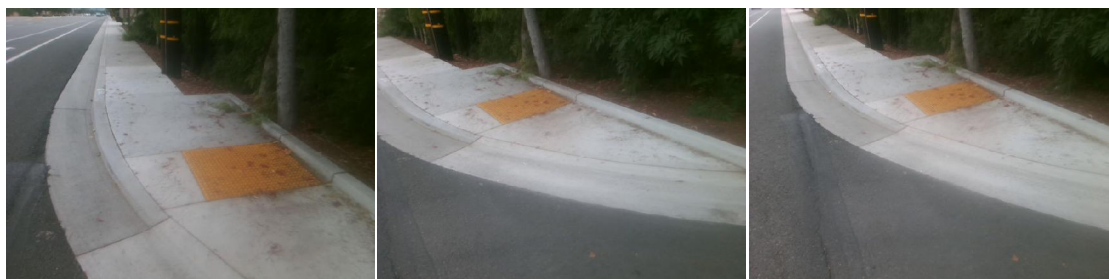
| Compliance | Description | Data | Compliance | Description | Data |
|---|---|---|---|---|---|
| N/A | Ramp Length (in) | 208 | N/A | Flare Type LT | |
| Yes | Ramp Width (in) | 75 | | | N/A |
| Yes | Ramp Run Slope (%) | 12.4 | N/A | Flare Slope LT (%) | N/A |
| | Crossing 1 Slope (%) | 11.5 | | | |
| | Crossing 1 Cross Slope (%) | 5.9 | | | |
