# Access Compliance Report Public Rights-of-Way (Curb Ramps)

Main Street: VANDERLIP\_AVE Cross Street: NEWPORT\_AVE Location: N

ADA ID: RPRK211007125958 Ramp Type: Type 1 - Perpendicular Diagonal Initial Pass/Fail: Fail Overall Compliance: No Severity Score: 32

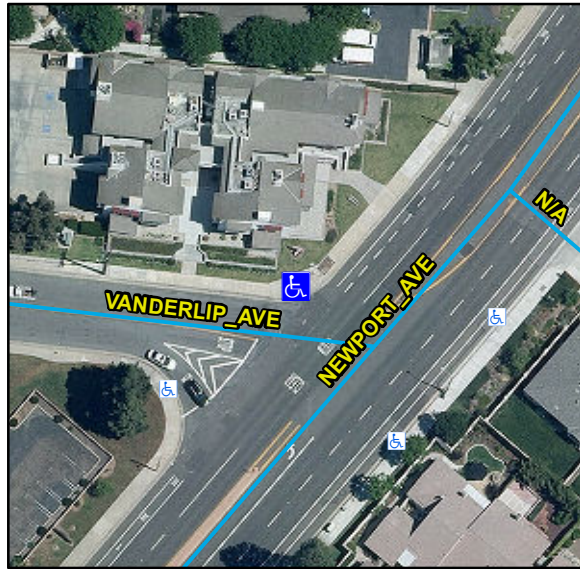
| Compliance | Description | Data | Compliance | Description | Data |
|---|---|---|---|---|---|
| No | Ramp Run Slope (%) | 12.1 | N/A | Flare Slope LT (%) | N/A |
| No | Ramp Cross Slope (%) | 2.8 | N/A | Flare Traversable LT | N/A |

Remove & Replace Curb Ramp With Two New Directional Ramps or Equivalent.
