# Access Compliance Report Public Rights-of-Way (Curb Ramps)

Main Street: NEWPORT\_AVE Cross Street: 17TH\_ST Location: SW

ADA ID: RPRK211007130941 Ramp Type: Type 1 - Perpendicular Diagonal Initial Pass/Fail: Fail Overall Compliance: No Severity Score: 32

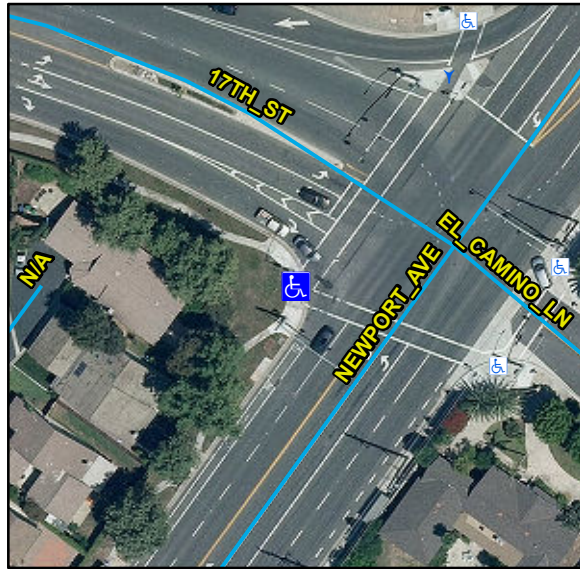
| Compliance | Description | Data | Compliance | Description | Data |
|---|---|---|---|---|---|
| No | Ramp Run Slope (%) | 14.1 | N/A | Flare Slope LT (%) | N/A |
| No | Ramp Cross Slope (%) | 4.7 | N/A | Flare Traversable LT | N/A |

Remove & Replace Curb Ramp With Two New Directional Ramps or Equivalent.

R304.2.2, R304.5.3, STD 1115
