# Access Compliance Report

## Public Rights-of-Way

### (Curb Ramps)

Main Street: NEWPORT\_AVE Cross Street: SKYLINE\_DR Location: SE

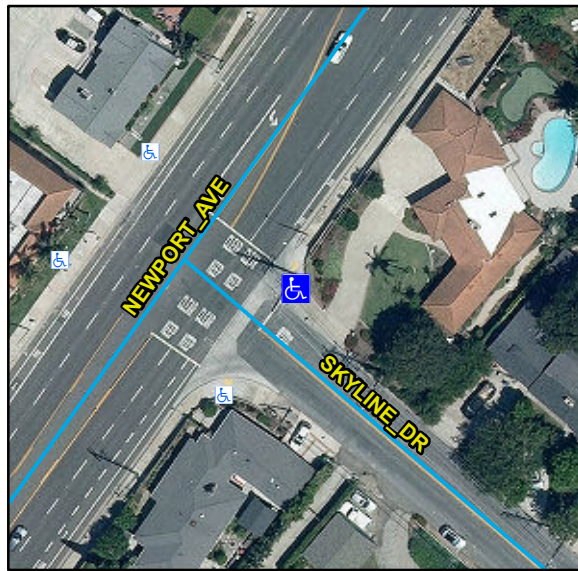
ADA ID: RPRK211007132853 Ramp Type: Type 1 - Perpendicular Diagonal Initial Pass/Fail: Fail Overall Compliance: No Severity Score: 0

| Compliance | Description | Data | Compliance | Description | Data |
|---|---|---|---|---|---|
| Yes | Overall Surface Condition: Acceptable | | Yes | Perp Joint Present | Yes |
| | Cross Gutter Present? | Yes | | Spandrel Present? | Yes |
| | Replace Cross Gutter? | Yes | | Replace Spandrel? | No |

**Remove & Replace Curb Ramp With Two New Directional Ramps or Equivalent. Replace Cross Gutter.**
