# Access Compliance Report Public Rights-of-Way (Curb Ramps)

Main Street: NEWPORT\_AVE Cross Street: LA\_COLINA\_DR Location: SE

ADA ID: RPRK211007134525 Ramp Type: Type 1 - Perpendicular Diagonal Initial Pass/Fail: Fail Overall Compliance: No Severity Score: 15

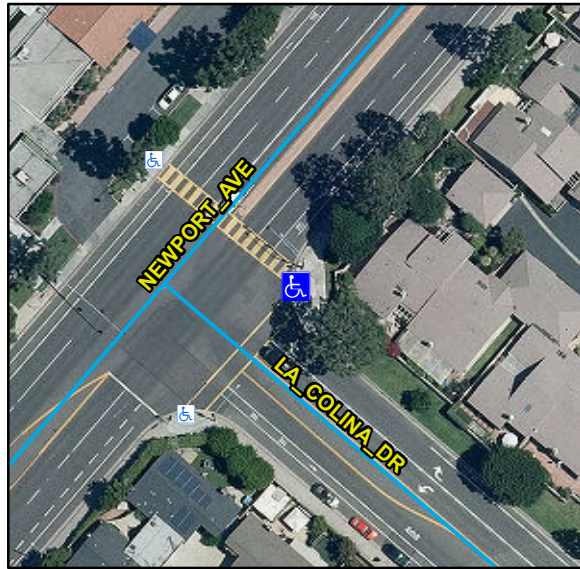
| Compliance | Description | Data | Compliance | Description | Data |
|---|---|---|---|---|---|
| No | Ramp Run Slope (%) | 11.7 | N/A | Flare Slope LT (%) | N/A |
| N/A | Gutter Ponding | N/A | No | Curb Slope | 12.3 |

Remove & Replace Curb Ramp With Two New Directional Ramps or Equivalent.

R304.2.2, STD 1115
