# Access Compliance Report Public Rights-of-Way (Curb Ramps)

Main Street: LA\_COLINA\_DR Cross Street: NEWPORT\_AVE Location: SW

ADA ID: RPRK211007134931 Ramp Type: Type 1 - Perpendicular Diagonal Initial Pass/Fail: Fail Overall Compliance: No Severity Score: 15

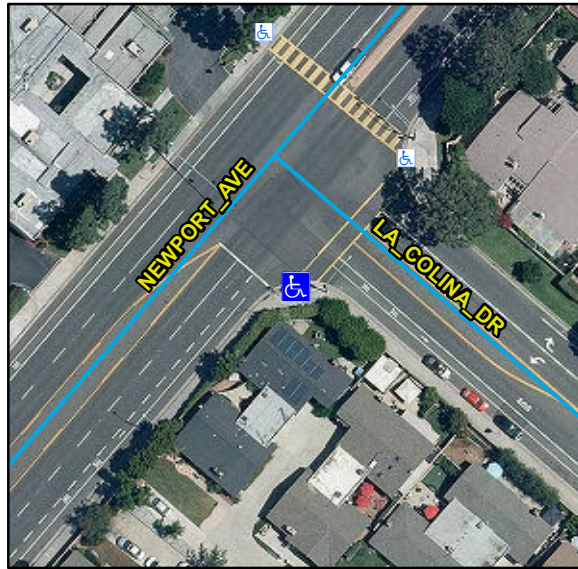
| Compliance | Description | Data | Compliance | Description | Data |
|---|---|---|---|---|---|
| No | Ramp Run Slope (%) | 11.4 | N/A | Flare Slope LT (%) | N/A |

Remove & Replace Curb Ramp With Two New Directional Ramps or Equivalent.
